A LEGACY OF NEARLY 500 YEARS OF MINING IN POTOSÍ, BOLIVIA: STREAM WATER QUALITY¹

W.H. Strosnider, F. Llanos, and R.W. Nairn²

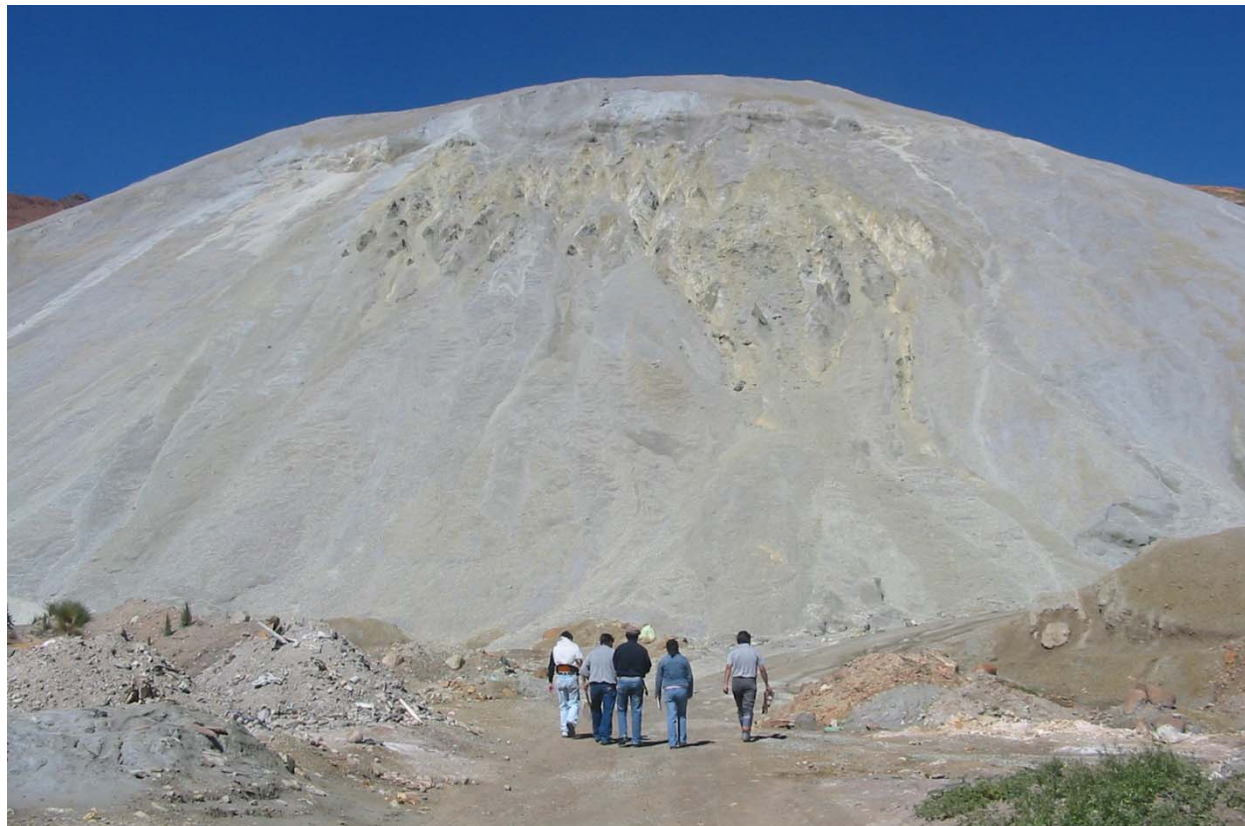
Figure 2: A portion of the Pailaviri tailings deposit which lies within the Huayna Mayu watershed. The Pailaviri tailings are less than 100m from Huayna Mayu, which drains to the Ribera de la Vera Cruz less than 2 km from the location pictured.

The AMD sources, the majority of which were characterized by Strosnider et al. (2007), that impact local waterways are represented on Fig. 1. Tailings deposits (Figs. 1 and 2), innumerable ore piles that dot the slopes of Cerro Rico, tailings discharges by ore processors and tailings within stream sediments are other probable ephemeral and permanent point and non-point sources of water quality degradation.

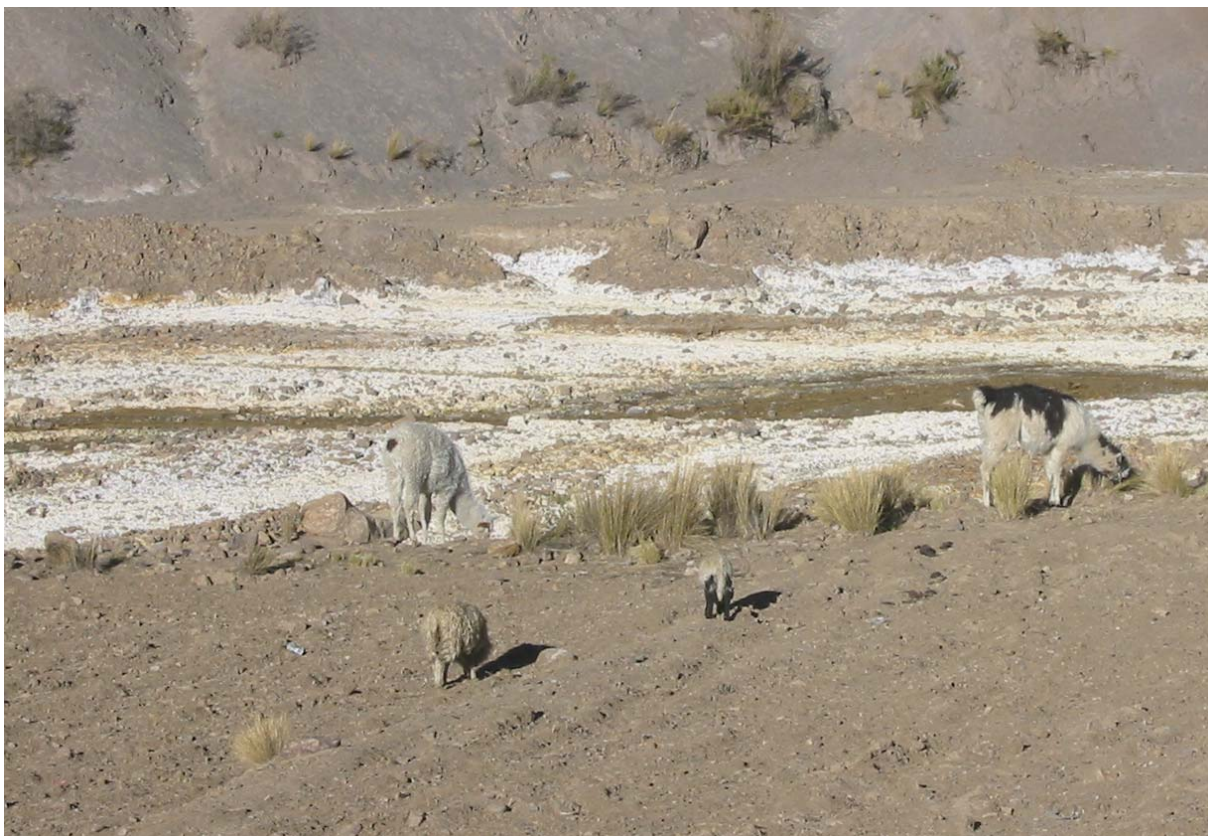
Figure 3: Llama and sheep grazing on a farm plot that has been prepared for planting aside a highly impacted reach of Jayac Mayu between JM2 and JM3.

An unnamed tributary to Jayac Mayu (JMUT) is a key water resource to a few farms upstream of the confluence. A cistern has been recently constructed approximately 10 m upstream of the confluence to capture and store water from the unnamed tributary before it is impacted by Jayac Mayu. Downstream of the confluence, Jayac Mayu borders small agricultural plots (Fig. 3), but does not appear to be used for irrigation.
